Detecting and Diagnosing a Rotor Design Weakness on New Hydrogenerators

Machine Data

Commissioning: 1999 Nominal Air Gap: 11 mm/0.433 in. Turbine Type: Bulb / Kaplan Bearing Layout: Generator Guide
 Power: 42 MW Stator Bore Dia.: 6.45 m/253.94 in. Nbr Blades: 4 Turbine Guide
 Speed: 112.5 rpm

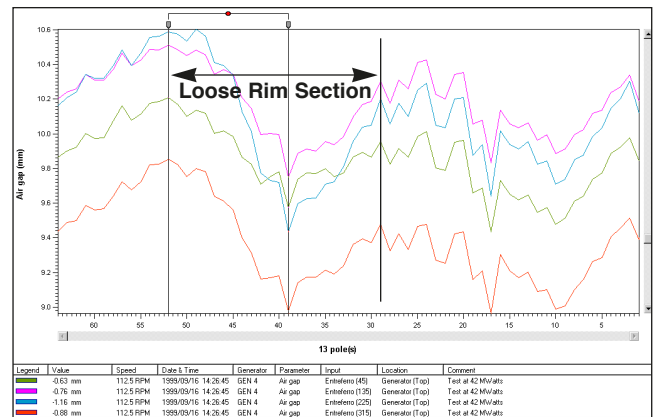
While at site to complete installation and commissioning of the ZOOM system, VibroSystM technician and the plant supervising engineer reviewed data acquired by the system on the other machines. They found an irregularity in the air gap results of one unit. At Full Load, the air gap sensors were measuring different rotor shapes (Figure 1). Sensor at 225° angle (bottom) was providing the most dramatic result. Comparison of each sensor at different operating conditions, ranging from Speed No Load (SNL) to Full Load (FL) demonstrated a transient bump between poles #29 and #52 resulting from a loose section of the rotor rim (Figure 2).

Figure 1: Signature graph of generator at Full Load showing a significant variation for the sensor at 225° (blue curve) between poles #29 and #52.

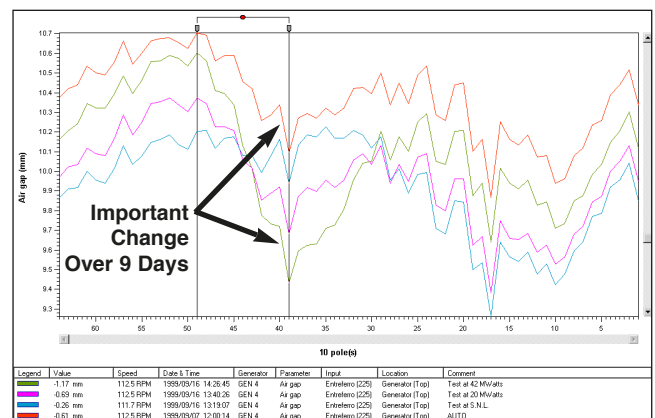
Figure 2: Signature graph of rotor profile at various operating conditions facing sensor at 225° and comparison with result 9 days earlier.

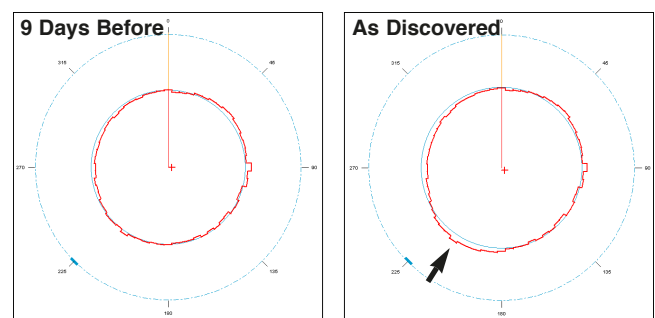
With gravity helping, the loose rim section protruded into the air gap when rotating towards the bottom, then returned to its position when passing at the top (Figure 3). This cyclic flexing was imposing stress on the rotor rim components. The maximum bump amplitude (most critical air gap) occurred when rotor pole #39 passed in front of the sensor at 225° angle. Comparing these results with data recorded at Full Load nine days before clearly showed that the situation was deteriorating very quickly and that a failure could potentially occur at any time.

Figure 3: Polar graphs of rotor profile 9 days apart measured by sensor at 225° (right) angle. Note the bump protrusion in the area between poles #29 and #52.

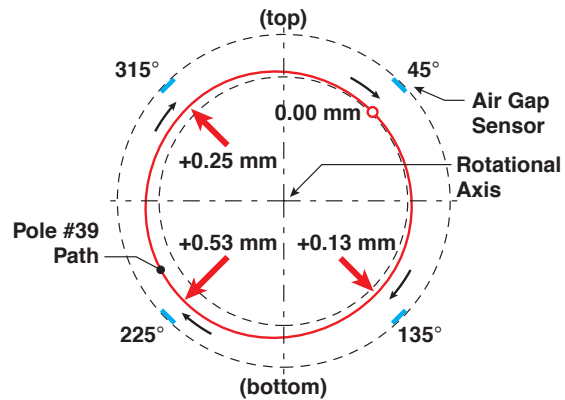
Figure 4: Illustration of pole #39 (most critical of the loose section) path over one rotation relative to its position facing sensor at 45°.
