Short Comings of Conventional Vibration Monitoring

Machine Data

Commissioning:	1999	Nominal Air Gap:	11 mm/0.433 in.	Turbine Type:	Bulb / Kaplan	Bearing Layout:	Generator Guide
Power:	42 MW	Stator Bore Dia.:	6.45 m/253.94 in.	Nbr Blades:	4		Turbine Guide
Speed:	112.5 rpm

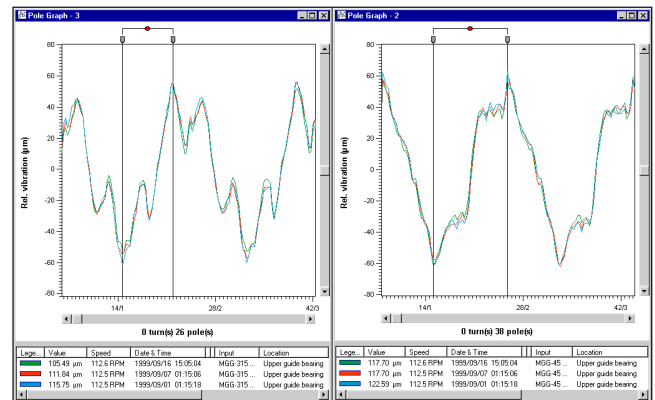
Comparison of vibration results for the same period showed that no significant change had yet been measured. Pole measurement graphs in Figure 1 indicate that the overall shape of each sensor curve remained similar while the amplitude slightly increased. Peak-to-peak vibration levels for all probes were still within or slightly above normal assembly tolerances². Further analysis of FFT and orbit graphs (Figures 2 and 3) did not show significant variations over the same period.

Figure 1: Comparison of shaft displacement measurements at Generator Guide Bearing (left: Y / 315°, right: X / 45°) taken on September 16th, nine days earlier, and two weeks before. Note how little the curves have changed: X varied from 105 to 115 µm and Y varied from 117 to 122 µm.

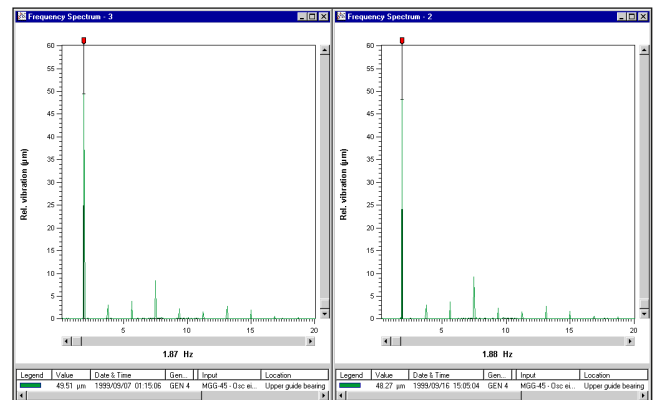
Figure 2: Frequency Spectrum graphs comparing FFT results of X (45°) axis probe at Generator Guide Bearing between September 16th (right) and nine days earlier (left). Again, the spectrums are very similar in amplitude and frequency.

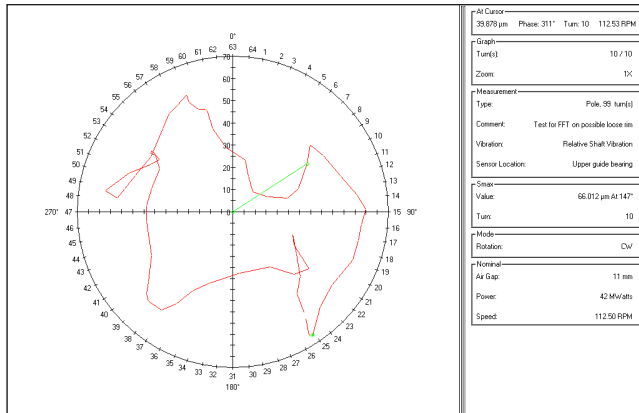
Figure 3: Typical shaft orbit at Generator Guide Bearing on September 16th. The cursor indicates the position of the shaft when pole #39 (most critical) faces air gap sensor at 225°.
