Short Comings of Conventional Vibration Monitoring

Machine Data

Commissioning:	1999	Nominal Air Gap:	11 mm/0.433 in.	Turbine Type:	Bulb / Kaplan	Bearing Layout:	Generator Guide
Power:	42 MW	Stator Bore Dia.:	6.45 m/253.94 in.	Nbr Blades:	4		Turbine Guide
Speed:	112.5 rpm

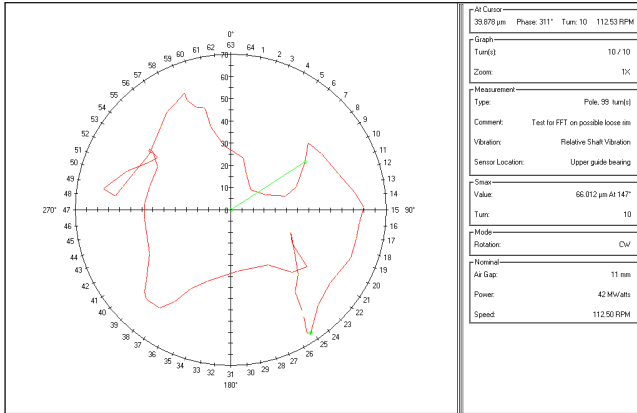
Figure 3: Typical shaft orbit at Generator Guide Bearing on September 16th. The cursor indicates the position of the shaft when pole #39 (most critical) faces air gap sensor at 225°.
