# Avoiding major damage on a new hydrogenerator by monitoring air gap at Igarapava H.E.P.P.

Authors: *Raimundo Jorge Ivo Metzker*, CEMIG  
*Marc R. Bissonnette*, VibroSystM  
*André Tétreault*, VibroSystM  
*Jackson Lin*, VibroSystM

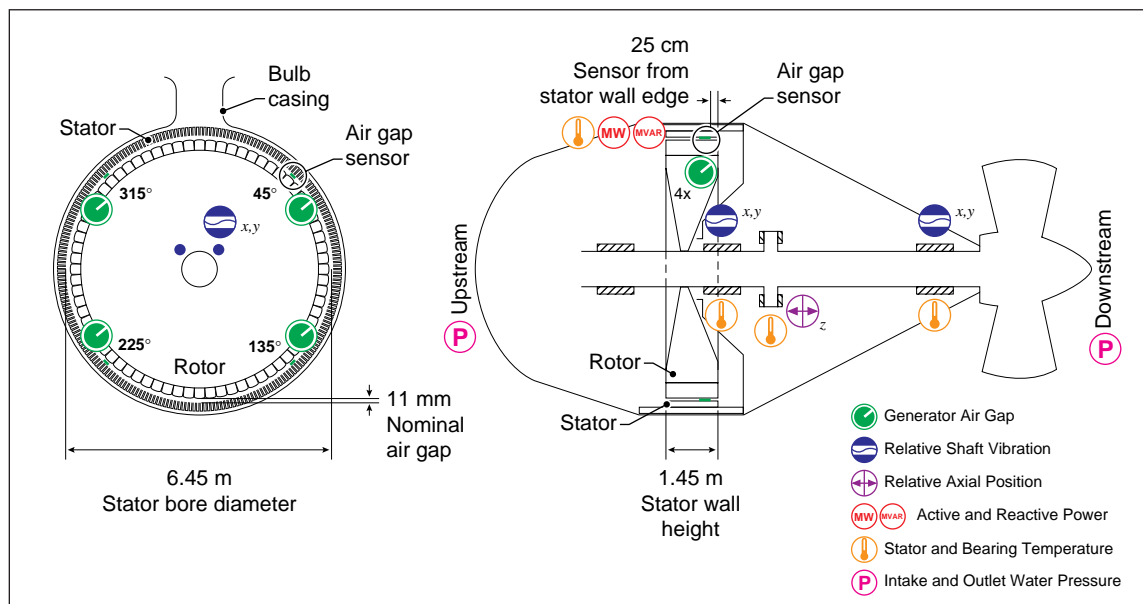
A total of four air gap sensors are installed on the perimeter of the stator core approximately 25 cm (or 10 inches) from the edge of the stator iron. Sensors are installed at the 45°, 135°, 225° and 315° locations (see **Figure 1**).

**Figure 1: Cross-sections of bulb unit showing air gap sensor locations on stator wall plus other monitored parameters.**

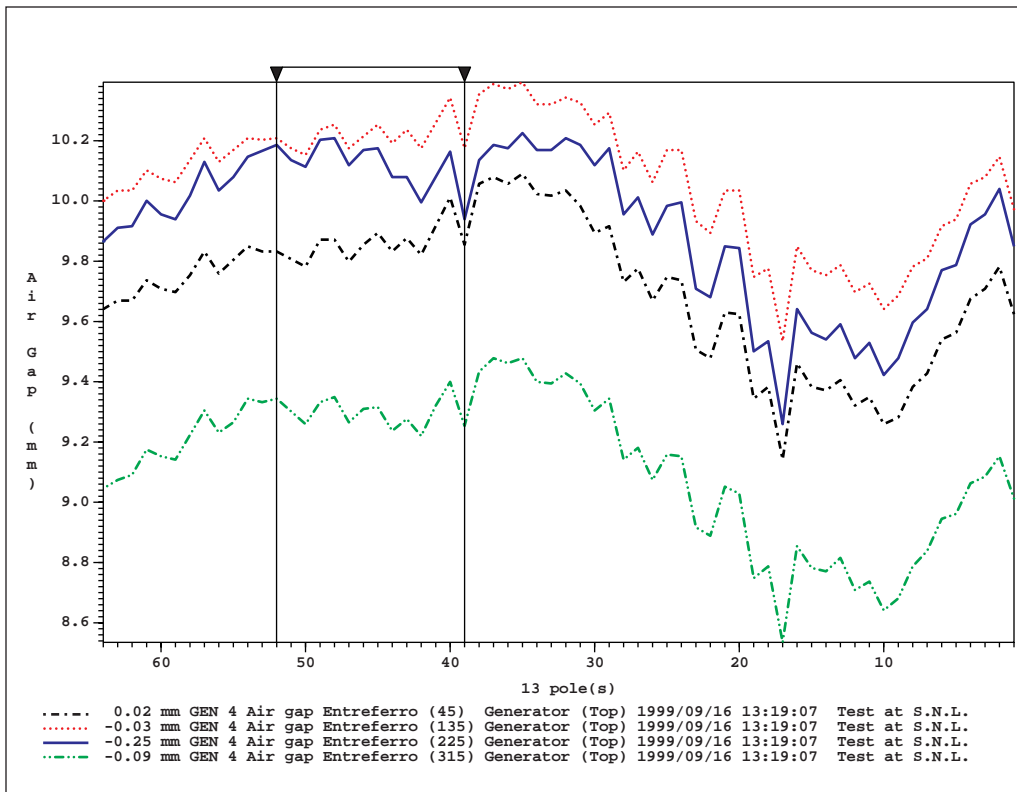
By isolating the signature of each of the four air gap sensors, it was possible to identify if the bump was permanent or transient (see **Figures 2 and 3**). A permanent bump would result in all four air gap sensors seeing the same signature trace. A transient bump would result in all four air gap signals showing a different trace. By using the ZOOM software, it was possible to determine that the bump amplitude varied depending upon the angle to which the rotor was turned. The maximum bump amplitude (or most critical air gap) occurred when rotor pole #39 passes in front of the 225° sensor.

Figure 2: Air gap signature of all four sensors showing rotor profiles at Speed No Load (S.N.L.) In all figures, delta markers indicate variations between a stable rim location (pole 59) and the worst moving rim location (pole 39) along with numerical values for each curve displayed at bottom left.

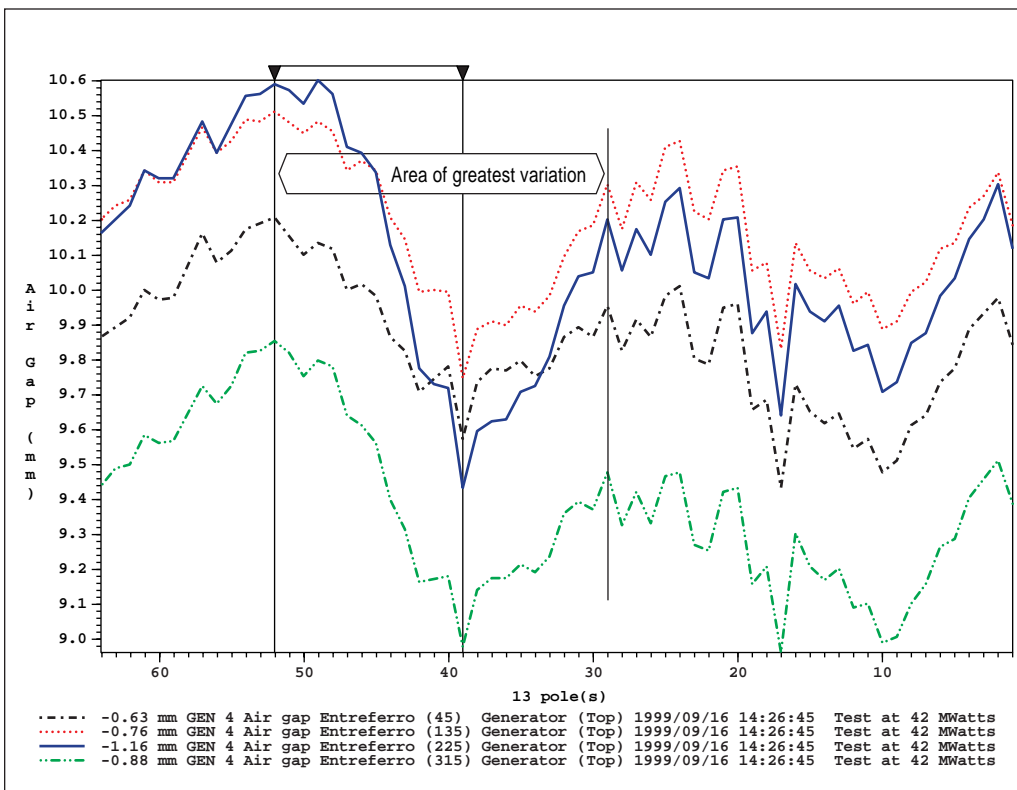
Figure 3: Air gap signatures of all four sensors at full load (42 MW). Note the dramatic shape variation for 225° sensor between poles 52 and 29 compared with other sensors and with Figure 2.

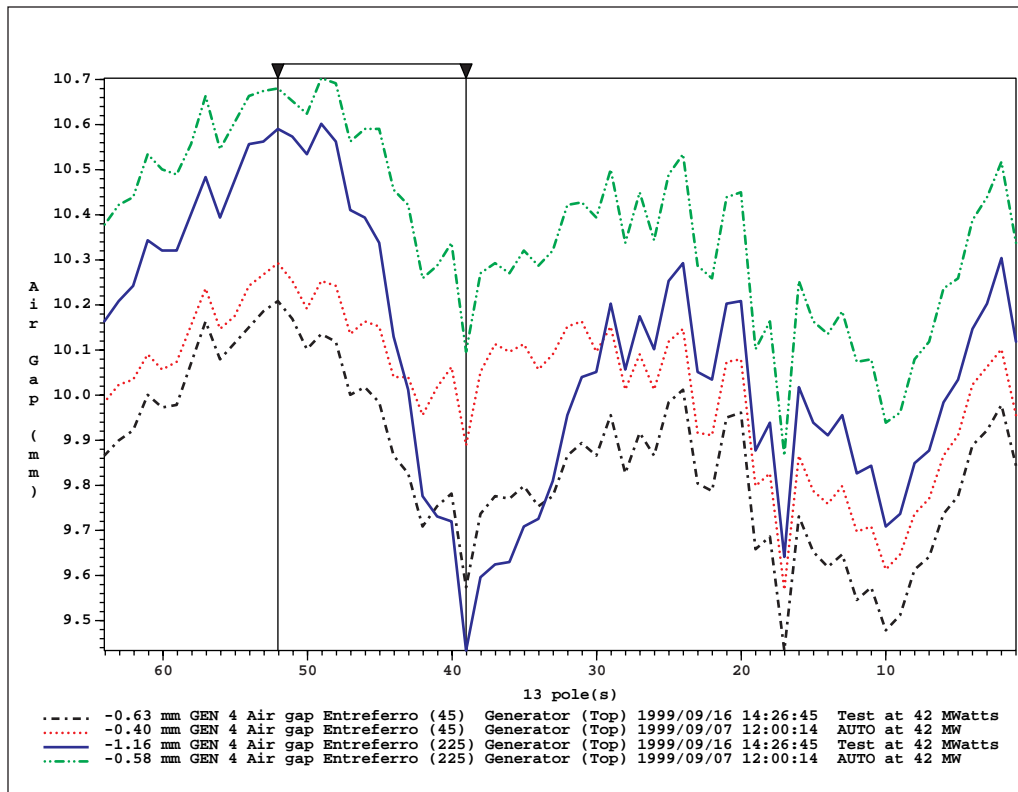
Figure 4: Air gap signature of opposite sensors at 45° and 225° showing rapid deterioration over a period of 9 days.

VibroSystM plotted the 225° and 45° sensors and compared these with the same data from a week earlier. From the signatures of **Figure 4** and data of **Table 1**, it was clear that even over the course of one week, there was significant deterioration of the air gap. Polar views of generator in **Figure 5** compares rotor rim profiles under two operating conditions (i.e. S.N.L. and full load) and in **Figure 6** compares rotor profiles at 42 MW load taken 9 days apart (September 7 and 16, 1999).

In studying the data, VibroSystM alerted CEMIG that the monitoring system clearly indicated a potential rotor-stator air gap failure could occur at any time.

Realizing the gravity of the situation and the potential danger of the imminent rotor-stator contact, the CEMIG supervising engineer immediately contacted the CEMIG head office. From its Belo Horizonte headquarters, CEMIG engineers were able to remotely access the ZOOM data via their remote ZOOM controller and confirm that the danger of an imminent rub was real. The CEMIG engineers printed the relevant ZOOM plots showing the results and faxed them to the generator manufacturer's project office. Upon further study, CEMIG shut down the machine and requested the generator manufacturer to inspect the rotor rim.

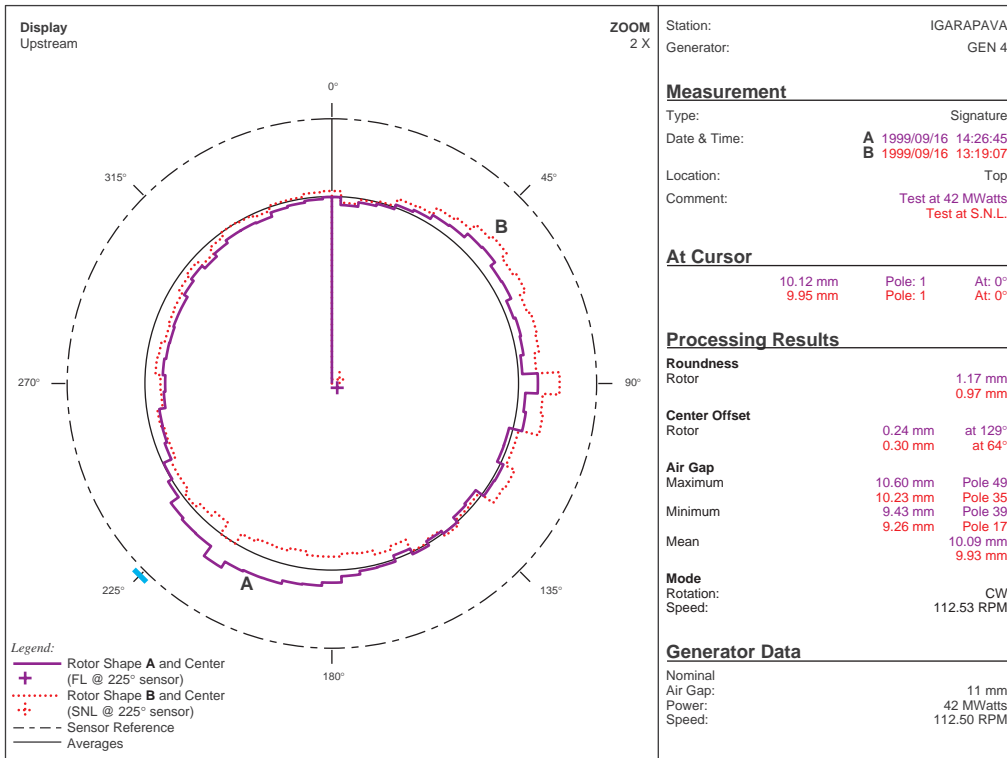
**Figure 5: Polar view of generator comparing rotor shapes at S.N.L. (B) and Full Load (A) using 225° sensor. Numerical values at right stress the various changes in roundness, offset, angle, best/worst locations.**

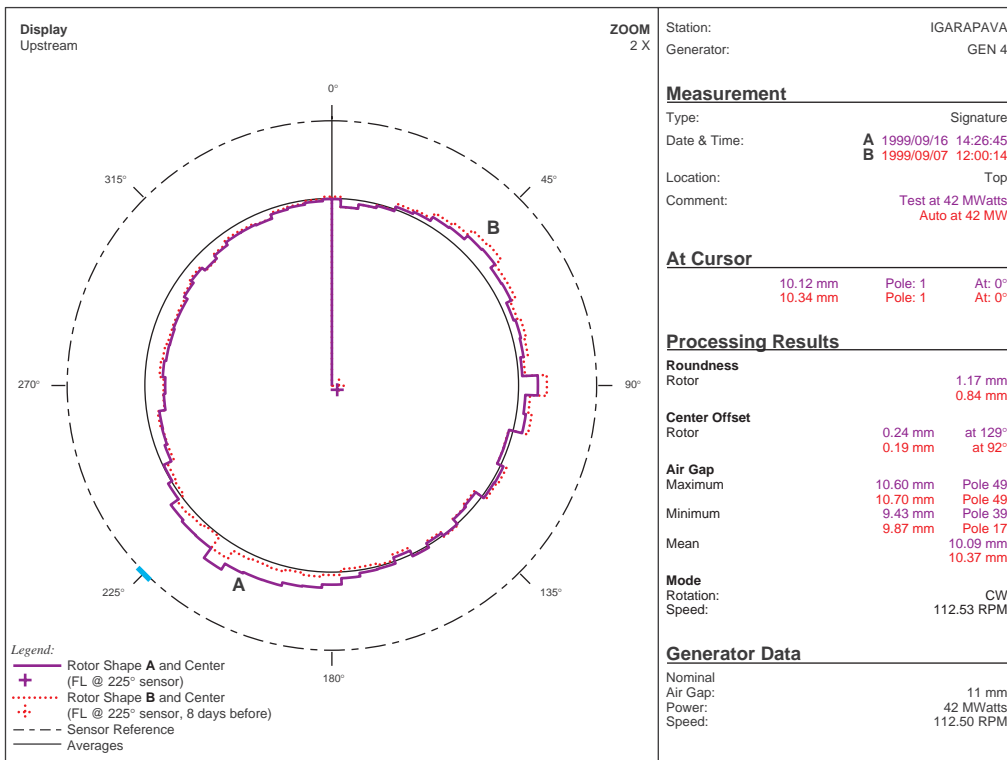
**Figure 6: Polar view of generator comparing rotor shape deterioration over a period of 9 days (at full load of 42 MW).**

Two days after the order was given to shut down the unit, the generator manufacturer visited the plant to conduct further investigations. It discovered that Unit 4 was in much worse condition than Unit 2 when its rotor had contacted the stator. Percussion tests were performed on the rotor rim bolts to the spider. Several bolts broke in the course of testing. It was evident that the rotor rim was loose on the spider and during machine rotation, this imbalance was overstressing the bolts and causing them to break. CEMIG and the generator manufacturer have performed a detailed generator design review to correct the problem and prevent its reoccurrence.
