Avoiding major damage on a new hydrogenerator by monitoring air gap at Igarapava H.E.P.P.

Authors: *Raimundo Jorge Ivo Metzker*, CEMIG
Marc R. Bissonnette, VibroSystM
André Tétreault, VibroSystM
Jackson Lin, VibroSystM

Rotor-Stator Air Gap Problem on Unit 4

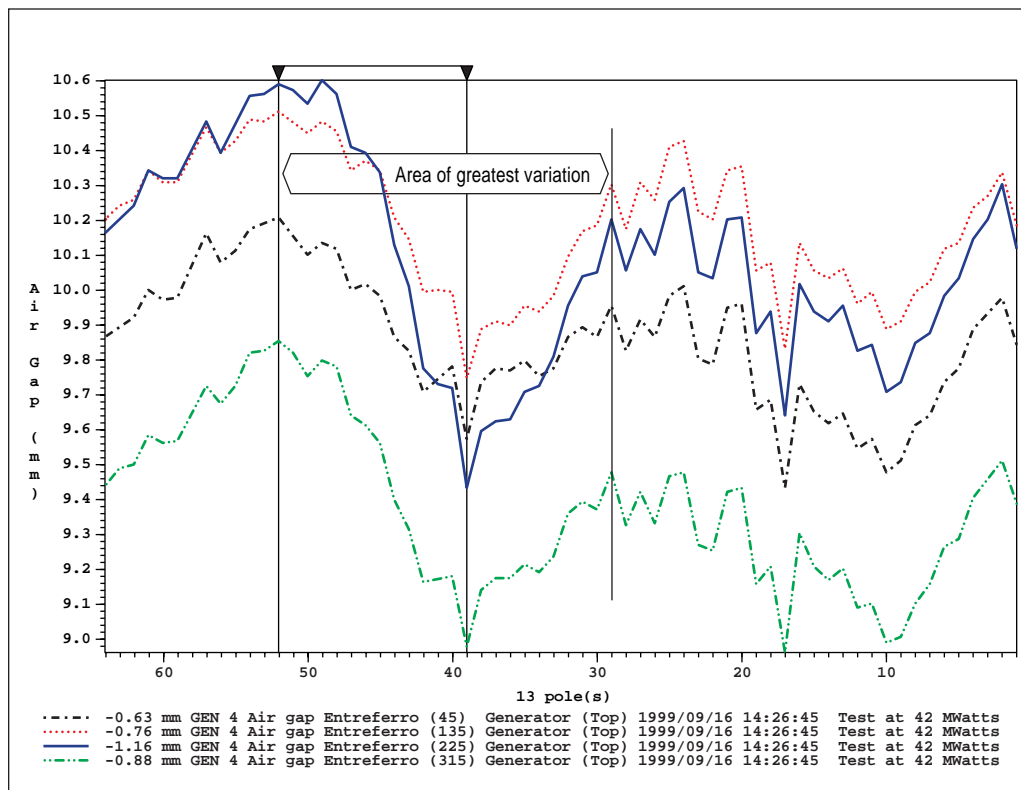
By isolating the signature of each of the four air gap sensors, it was possible to identify if the bump was permanent or transient (see **Figures 2 and 3**). A permanent bump would result in all four air gap sensors seeing the same signature trace. A transient bump would result in all four air gap signals showing a different trace. By using the ZOOM software, it was possible to determine that the bump amplitude varied depending upon the angle to which the rotor was turned. The maximum bump amplitude (or most critical air gap) occurred when rotor pole #39 passes in front of the 225° sensor.

Figure 3: Air gap signatures of all four sensors at full load (42 MW). Note the dramatic shape variation for 225° sensor between poles 52 and 29 compared with other sensors and with Figure 2.

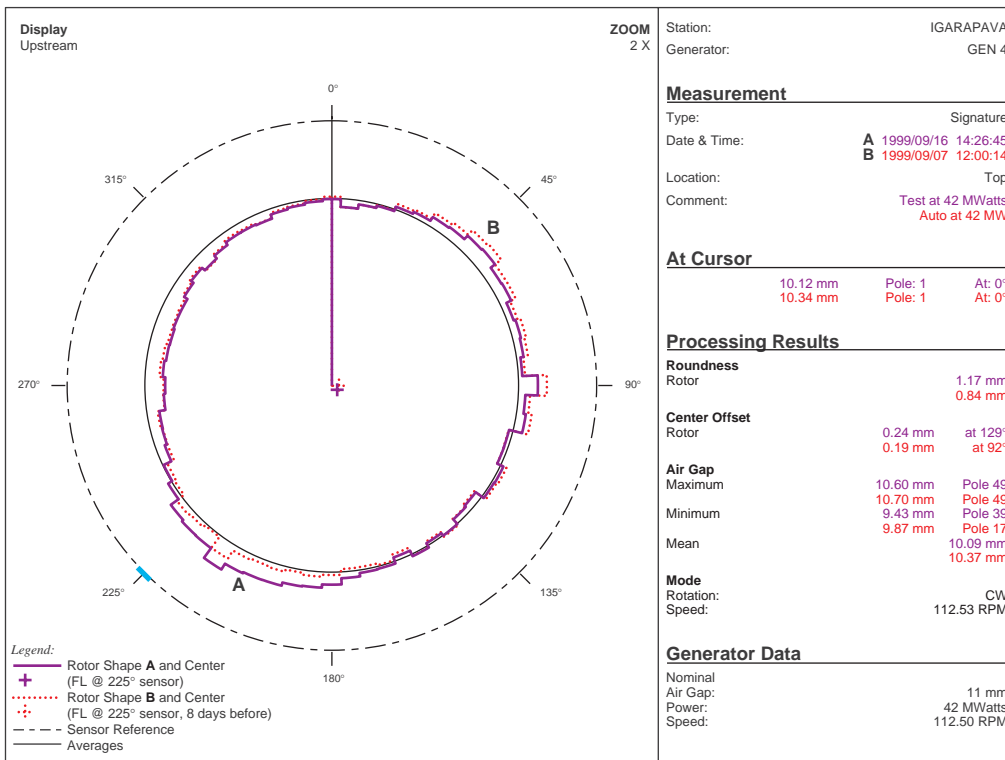
In studying the data, VibroSystM alerted CEMIG that the monitoring system clearly indicated a potential rotor-stator air gap failure could occur at any time.

Figure 6: Polar view of generator comparing rotor shape deterioration over a period of 9 days (at full load of 42 MW).
