# Concrete Expansion – R.H. Saunders GS Innovative Structural Rehabilitation & Mitigation Effectiveness

*Keith T. Eastman, Ontario Power Generation, Cornwall, ON, Canada  
John Deans, Kinectrics, Toronto, ON, Canada, and  
Edward S. Li, Ontario Power Generation, Cornwall, ON, Canada*

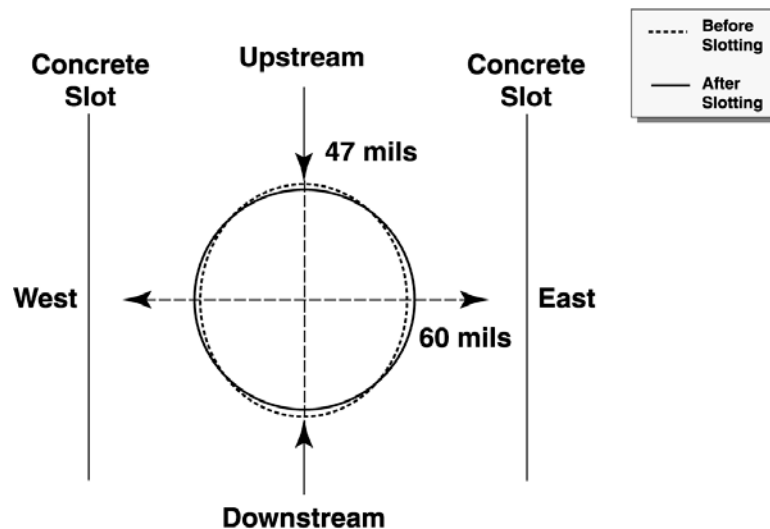
Figure 3 - Diametrical change in runner clearance

The immediate response of concrete slotting was beneficial. Re-establishment of the expansion/contraction joints resulted in reduced longitudinal compressive stresses in the concrete and partial rounding of the throat ring liners. The average diametrical runner clearance decreased 47 mils in the transverse direction and increased 60 mils longitudinally as predicted by the analytical model. See Figure 3.

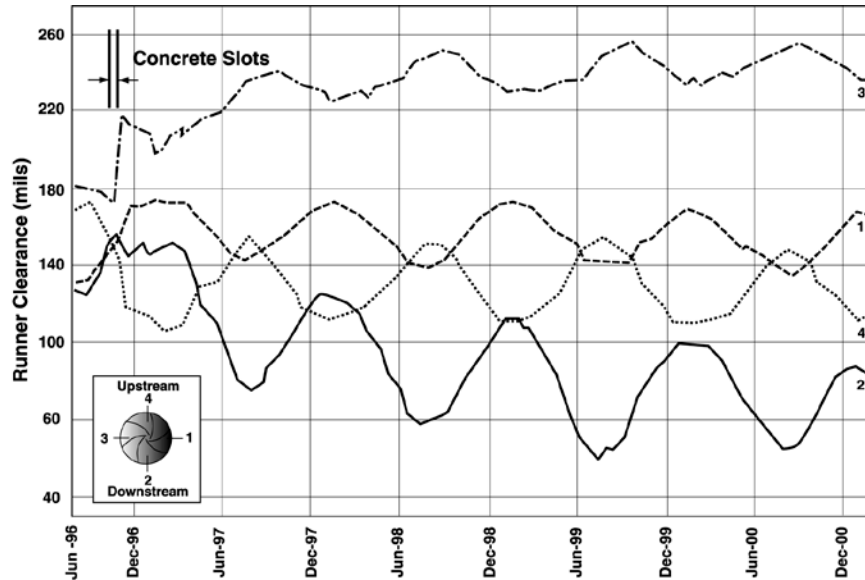
Subsequent to the slotting program, however, the runner clearances have decreased, in the vicinity of the downstream proximity probes, at a rate of 10 mils/year. See Figure 4. This is due to the continued relief of longitudinal compressive stresses. It is expected that this trend will reverse once the compressive stresses due to continued concrete expansion overcome the temporary relief provided by the contraction joint slots.

Figure 4 – Runner clearance – 10 mils/year decrease (downstream)

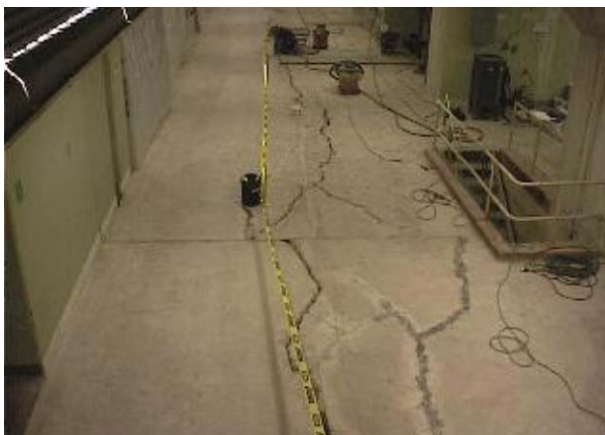
*Figure 5 - Tile and mortar bed removed exposing extensive cracking of underlying concrete*

An assessment of the generator floor condition revealed that over 60% of the ceramic tiles had debonded from the underlying mortar bed and many tiles were damaged. In addition, 60% of the mortar bed had debonded from the underlying concrete and was found to be friable and damaged. Separation of the suspended slab along the mass concrete interface (i.e. bearing area) resulted in extensive cracking of the concrete, which contributed to failure of the tile floor system as illustrated in Figure 5. As a result, it was decided to replace the ceramic tiles and mortar bed.

Analysis of the failure mechanisms identified the need to isolate the new flooring system from the main concrete structure to allow for future concrete expansion.

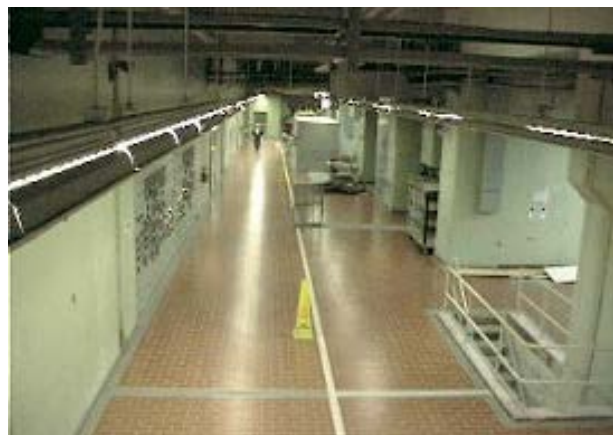
*Figure 6 - New generator floor*

After assessing each system and experimenting with the epoxy-based systems, the existing floor was replaced with a new mortar bed and ceramic tiles. This was the most practical and cost effective option. The new floor is shown in Figure 6.

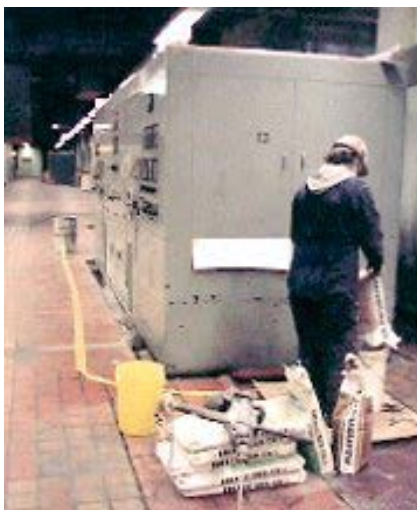
The governor cabinet concrete supports had been severely damaged due to concrete movement. Lateral movement (up to  $\frac{3}{4}$  in.) caused severe cracking and spalling of the concrete. Repairs entailed the removal and replacement of the damaged concrete, addition of new steel column supports with sliding Teflon pads to accommodate future movement and extensive structural grouting of numerous fractures in the concrete. See Figures 7 and 8. Post tensioning of the existing reinforced concrete columns was undertaken. These solutions were implemented based on ease of construction, space restrictions and operating requirements

*Figure 7 - Preparing to grout around a governor cabinet*

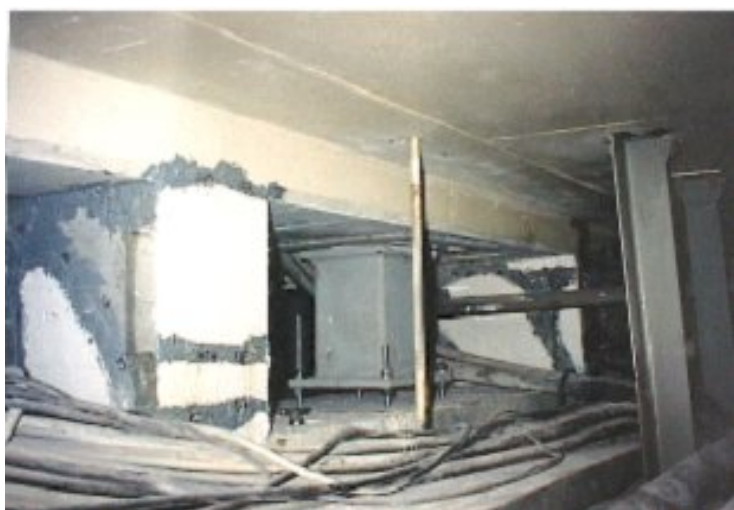
*Figure 8 - Structural grouting of columns and new steel column support*

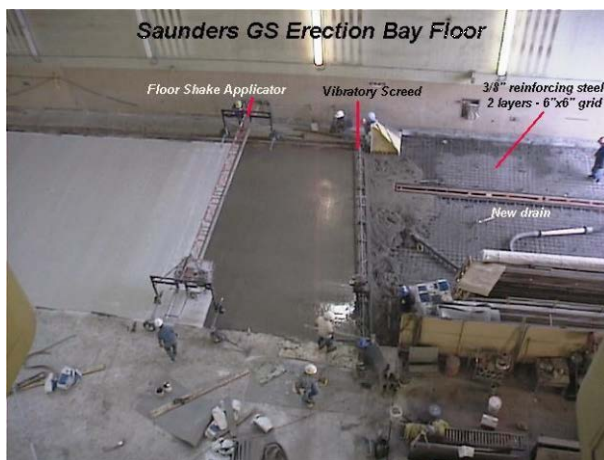
Over 90% of the ceramic floor tiles had debonded from the underlying mortar and numerous tiles had been damaged. The mortar bed had also been damaged and the topping slab was found to be intact.

*Figure 9 - Erection bay floor replacement*

Since the floor area is exposed to heavy traffic a new reinforced concrete slab and coloured floor shake hardener were installed. Expansion/isolation joints were installed around the perimeter of the floor area to create isolation and accommodate future movements in the floor. A 4,000 psi non-air entrained concrete containing water reducing and super plasticizing admixtures was used to increase workability during placement. Control joints were installed along both directions of the floor slab and where obstructions existed along the floor area. Both the control joints and existing expansion/contraction joints were filled with flexible epoxy and polyurethane sealant. See Figures 9 and 10.

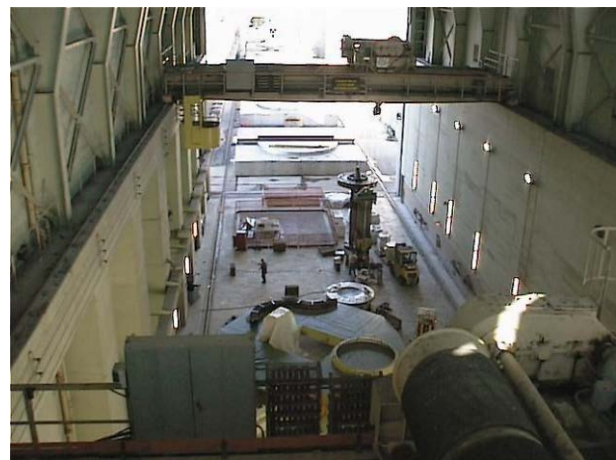
*Figure 10 - New erection bay floor*

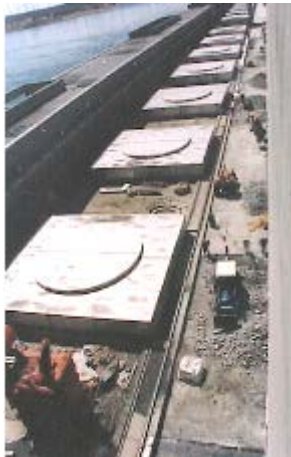
Concrete expansion contributed to extensive water leakage from the generator roof deck onto the generator floor. The generator roof deck consists of a walkway, laydown areas and road. Nearly 40,000 ft<sup>2</sup> of topping slabs 6 in. thick and underlying waterproof membranes required removal and replacement. The waterproofing systems had deteriorated (i.e. embrittlement and cracking) over forty years and were further damaged by concrete movement. Extensive freeze-thaw damage to the topping slabs was the predominant mechanism of deterioration.

*Figure 11 - Generator roof deck roadway and laydown area concrete removal*

Concrete deterioration was most extensive along the generator roof deck roadway. Thus, the entire topping slab required removal. See Figure 11. The condition of the existing topping slab along the walkway and laydown areas varied necessitating different rehabilitation methods. In areas of significant deterioration, the topping slabs were removed and replaced. Where localized damage and cracking were evident, the topping slabs were repaired. New waterproofing membranes were installed along the entire generator roof deck. New concrete topping slabs were placed along the entire roadway and several laydown areas. The new topping slabs consist of 4,000 psi fibre-reinforced designed concrete. See Figure 12.

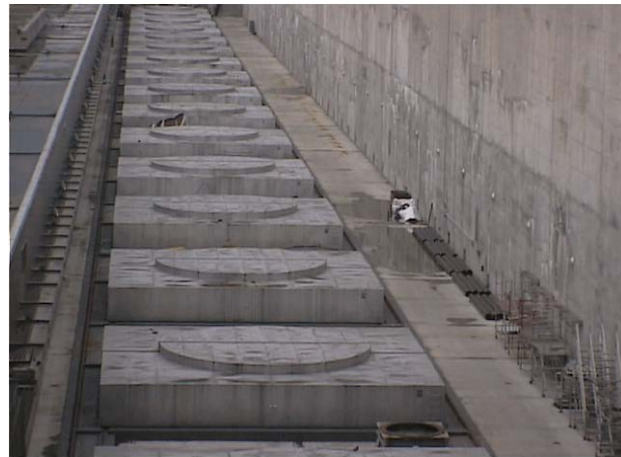
*Figure 12 - New generator roof deck roadway, laydown areas and walkway*

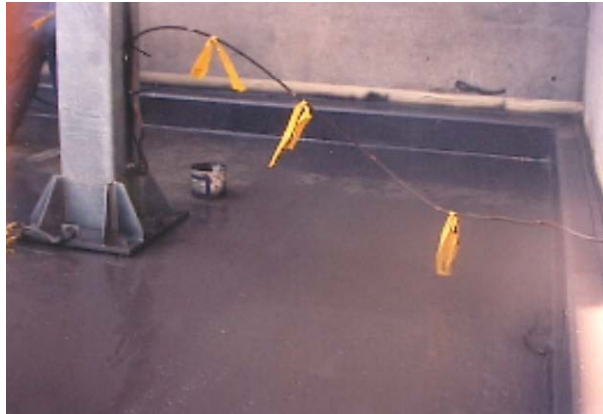
Previous inspections of the bays indicated that the liners were no longer completely water tight due to local cracking and deterioration of the concrete and joint sealant.

Figure 13 - Transformer bay oil containment liner

The repair consisted of local patching of the concrete, replacement of the existing deteriorated joint sealant, surface preparation of the concrete by sandblasting methods and application of a two-component polysulphide base coating. This material was selected as a result of its chemical and UV resistance, and flame retardant and crack bridging characteristics. It provides oil resistance and a leak-proof barrier to transformer oil in the event of a transformer oil spill. The coating also provides a protective layer over the concrete reducing the rate of deterioration and extends the life of the concrete structure. See Figure 13.

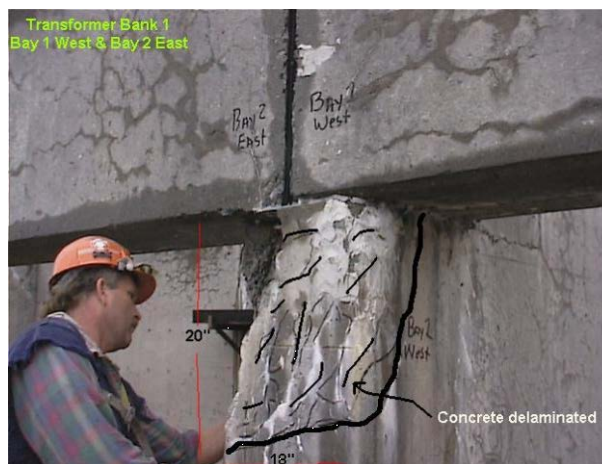
Reinforced concrete beams span the front of each transformer bay supported by fire separation walls. The sections of the beams within the wall bearing support area had sustained damage due to concrete movement and freeze-thaw action. The damage consisted of reduced beam bearing area, loss of reinforcing steel concrete cover, spalled and delaminated concrete, and fractures in the concrete accelerated by water infiltration. See Figure 14.

Figure 14 - Beam bearing area delaminated concrete

- Removal and replacement of all deteriorated concrete and joint sealant,
- Installation of steel knee brackets and post-tensioned anchors to provide additional bearing support for the transformer bay beams,
- Structural repair of major fractures in the concrete by epoxy grouting.

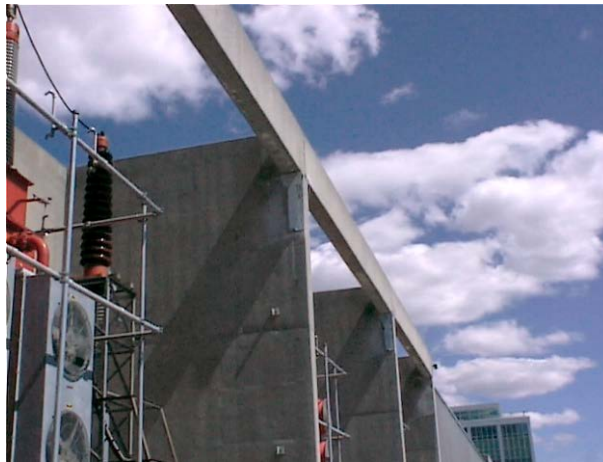
*Figure 15 - Transformer bay beams and new steel brackets*

A silane-based water proofing sealer was also applied to the beams to extend their life. See Figure 15.
