Avoiding major damage on a new hydrogenerator by monitoring air gap at Igarapava H.E.P.P.

Authors: *Raimundo Jorge Ivo Metzker*, CEMIG
Marc R. Bissonnette, VibroSystM
André Tétreault, VibroSystM
Jackson Lin, VibroSystM

Rotor-Stator Air Gap Problem on Unit 4

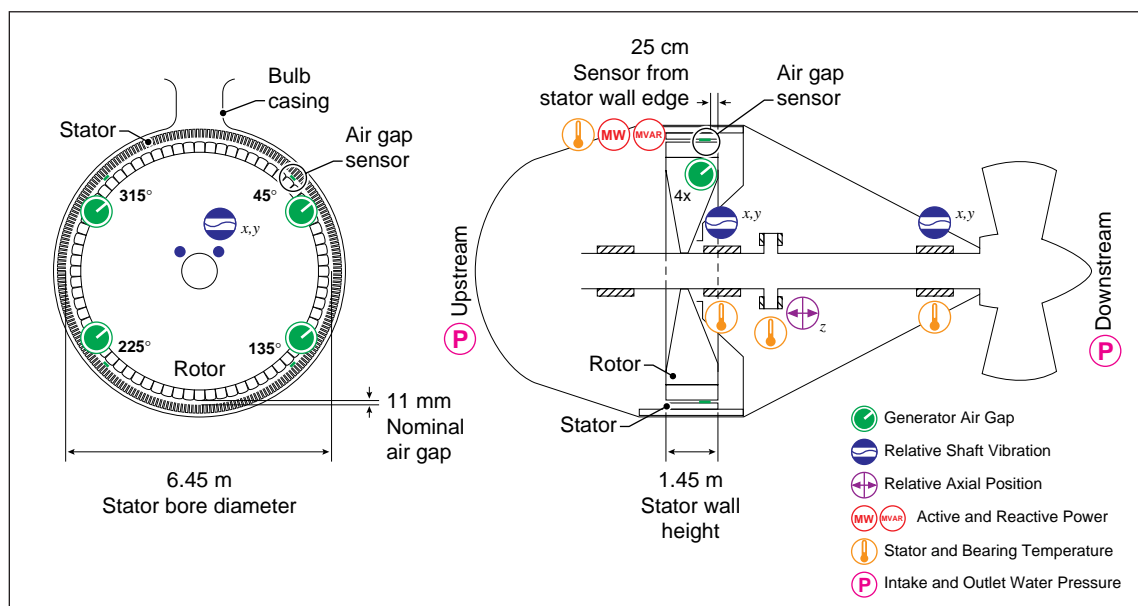
A total of four air gap sensors are installed on the perimeter of the stator core approximately 25 cm (or 10 inches) from the edge of the stator iron. Sensors are installed at the 45°, 135°, 225° and 315° locations (see **Figure 1**).

Figure 1: Cross-sections of bulb unit showing air gap sensor locations on stator wall plus other monitored parameters.
